# Manhole Inspection Summary

Manhole # S21G\_\_058MH

**Location** Address: **1839 MONROE-FULTON**

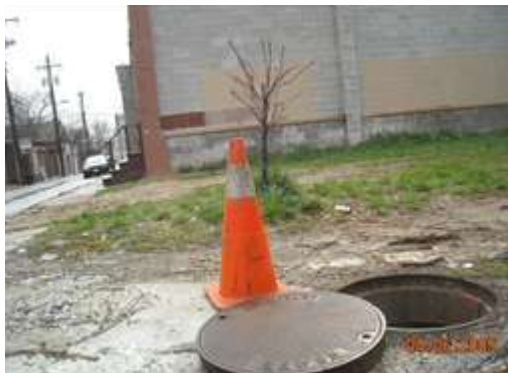
Location View

MANHOLE LID PREVIOUSLY  
REPLACED BY REI/DRAYCO

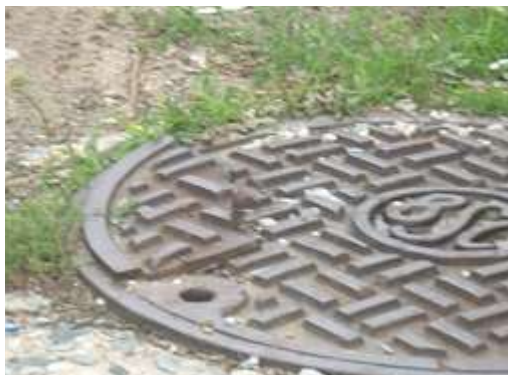
Defect 1

BROKEN MANHOLE COVER

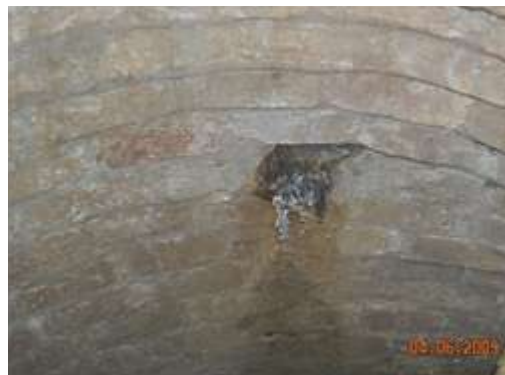
Defect 3

PIPE INTRUSION IN CORBEL WALL -  
ABANDONED FRESH WATER  
CLEANOUT

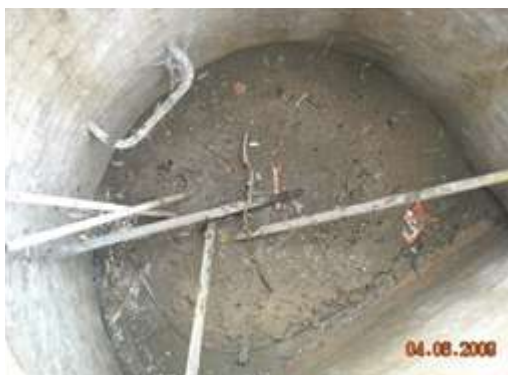
Defect 2

Condition: ☐ Sound ☐ Cracked ☐ Root Intrusion ☐ Deteriorated ☐ Leaks ☒ **Debris**

DEBRIS IN CHANNEL

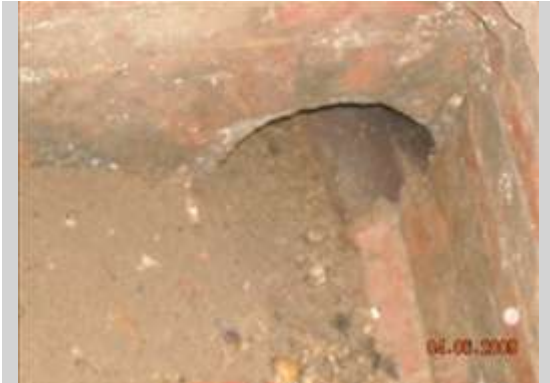
12 O'Clock Outflow

MUD AND SILT 2" IN PIPE

Deposits: ☐ None ☒ **Mud** ☐ Sludge ☐ Debris ☐ Grease

Silt Depth: **2** (in.) Deposits Extent: **Light**
